UNIVERSAL JOINT FAILURE

2003-2006
JEEP WRANGLER RUBICON

THE PROBLEM SOLVER®

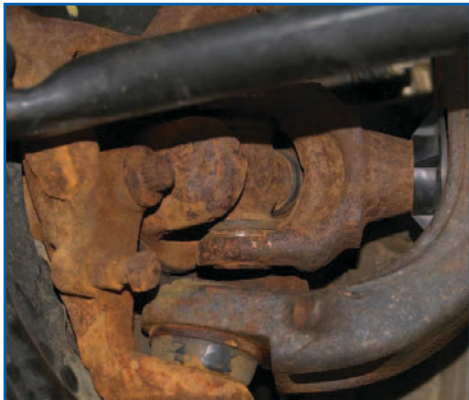
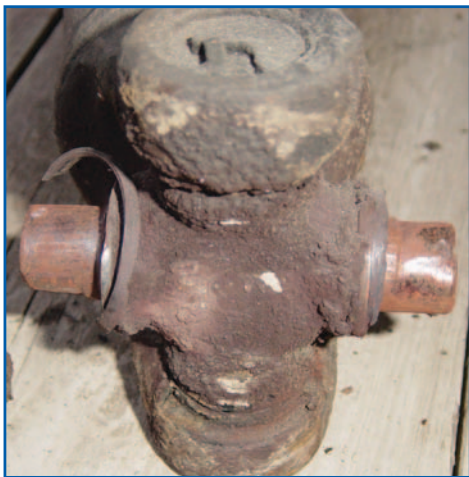
Universal joint can break or seize up

Owners of the trail-ready Jeep Wrangler Rubicon may experience driveline failures (universal joints breaking or seizing, and excessive corrosion) at the wheel end or driveshaft or axle. Since owners of these vehicles often take them off-road, they may be interested in upgrading their driveline to a stronger product option.

MOOG® Super Strength™ Greaseable Universal Joints

MOOG® Super Strength™ Greaseable Universal Joints mounted at the axles and driveshaft are recommended for Jeep Wranglers that may be taken off-road. These u-joints are designed to handle high torque and stress, and their greaseable design allows fresh lubrication to reach critical areas and enables the flushing of contamination. In addition, the MICRO SHIELD™ coating helps protect against rust and corrosion.
